# WATER QUALITY MEMORANDUM

Utah Coal Regulatory Program

RE: 2008 First Quarter Water Monitoring, Genwal Resources, Inc., Crandall Canyon Mine, WQ08-1, Task ID #3138

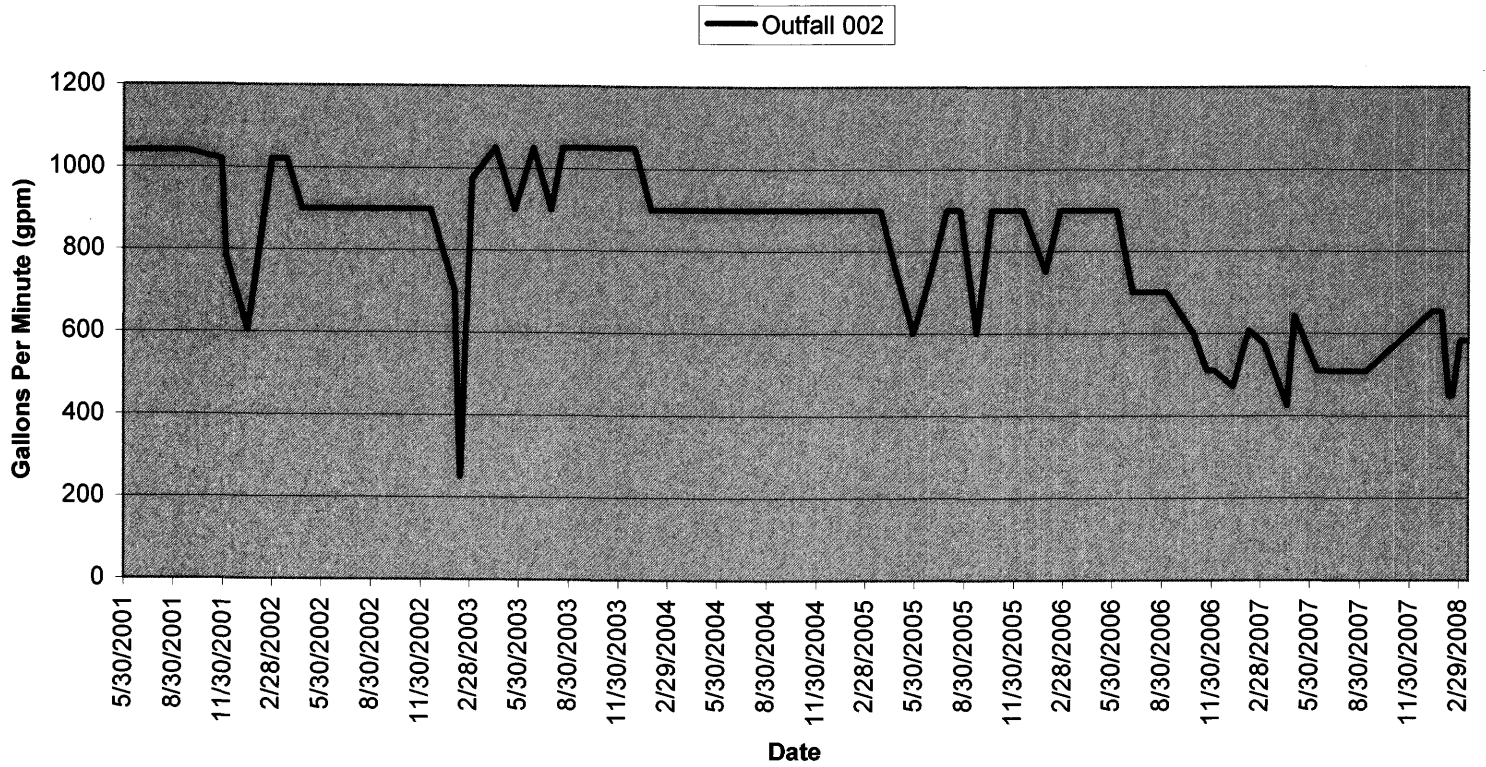
## Mine-Water Discharge

As discussed above, the mine-water began to discharge from around the temporary seals of the north portals in approximately mid-January (exact date unknown). The Permittee constructed a series of drains adjacent to the temporary seals and was successful in routing the mine-water discharge directly into Crandall Creek as was done during active mining operations.

Six sampling events of the mine-water discharge were conducted this quarter. 4 of the 6 sampling events produced analytical results that were outside of the compliance levels established by the Permittee's UPDES discharge permit.

Continued data collection and monitoring of the mine-water discharge will be necessary to determine if a trend is emerging relative to TDS and T-Fe. The data will be essential in determining whether the mine-water discharge remains in compliance with the UPDES permit.

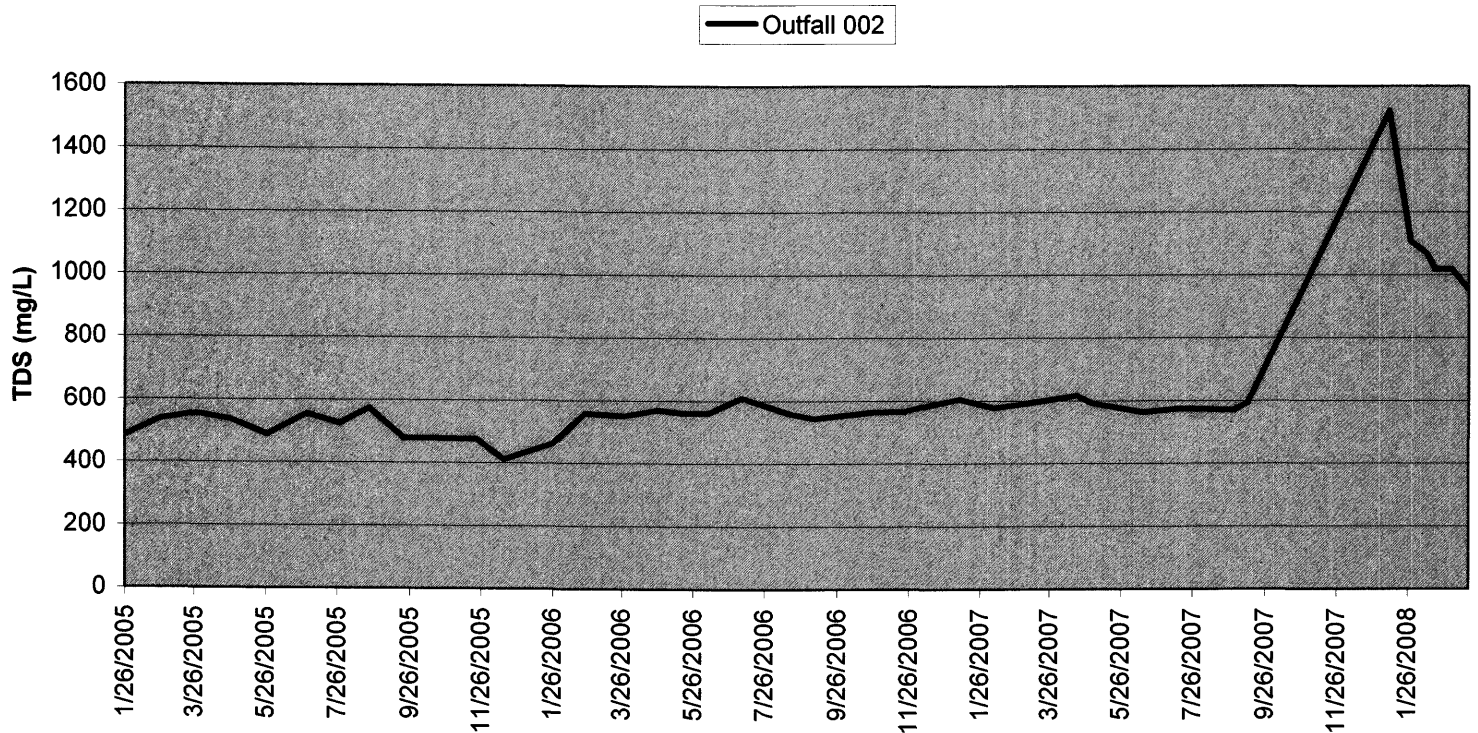
## Total Dissolved Solids (TDS)

The compliance level for TDS (as established by the UPDES discharge permit) is 1,200 ppm. The sampling events of January 10<sup>th</sup> and January 28<sup>th</sup> produced analytical results of 1,523 ppm and 1,108 ppm respectively.

At this point, it's unclear as to what's causing the spikes in TDS and T-Fe. Re-entering the mine is not an option. Additionally, the TDS and T-Fe data collected during this quarter is insufficient to determine what (if any) trend is being produced as a result of the mine-water discharge. Additional monitoring/data collection is necessary.
